Idaho Transportation Department Bridge Inspection Report

Bridge Key:	30315	Structure Name:	95907A 0.24
(6)Features Intersected:	BNRR;UPRR & DEEP CREEK	(9)Location:	0.1 S. NAPLES
Facility Carried(Route):	S5907;DEEP CRK LP	Admin Jurisdiction:	2100 Boundary County
Xref Structure Name:		District:	01

Inspector Number and Name: 1021 - Dylan Moss, Collins Engineers

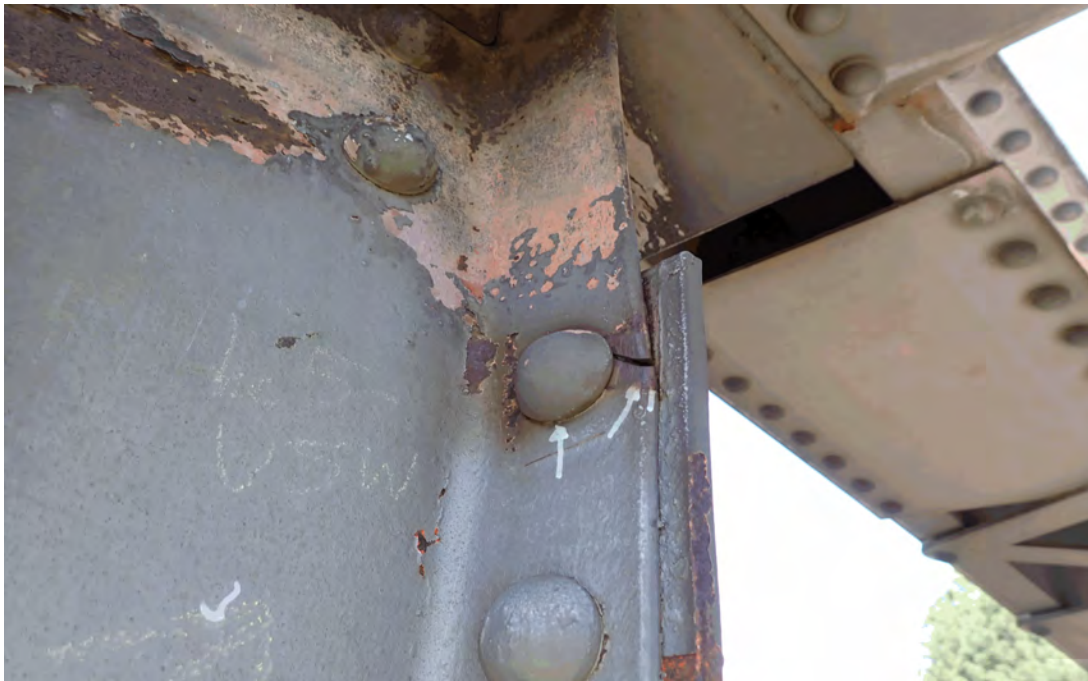
(CS 3) Vertical L5E-U5E has a crack from a rivet extending to the channel edge on the northwest flange at the upper connection. Vertical L5W-U5W has a crack from a rivet extending to the channel edge on the northeast flange just below the upper connection. Vertical L5W-U5W has a crack on both sides of the rivet on the southeast flange at the lower brace connection. Vertical L5E-U5E has a crack from a rivet extending to the channel edge on the northeast flange.

(CS 3) Crack in the northeast flange of L5W-U5W at U5W.

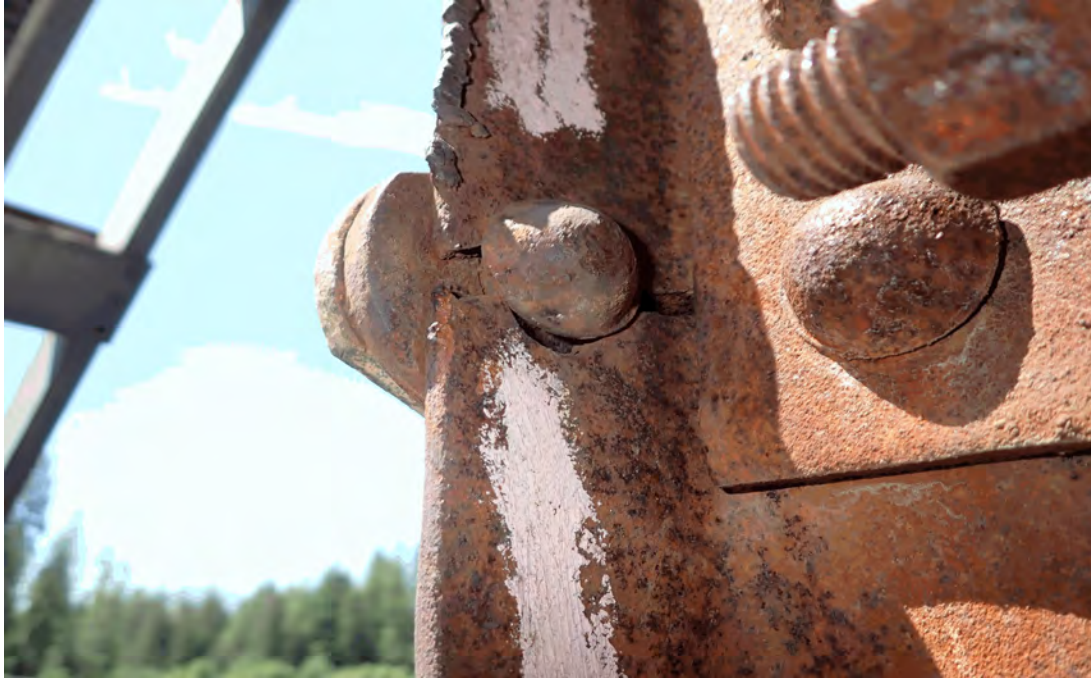
(CS 3) Crack in the northeast flange of L5W-U5W at the lower sway brace connection.

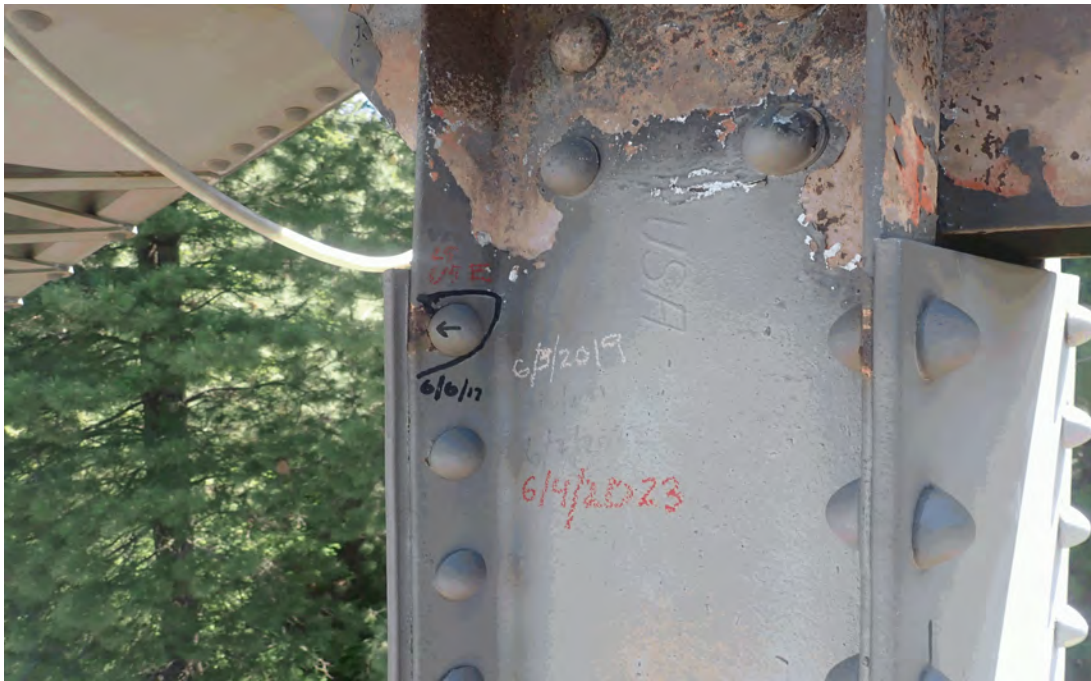
(CS 3) Crack in L5E-U5E at U5E.

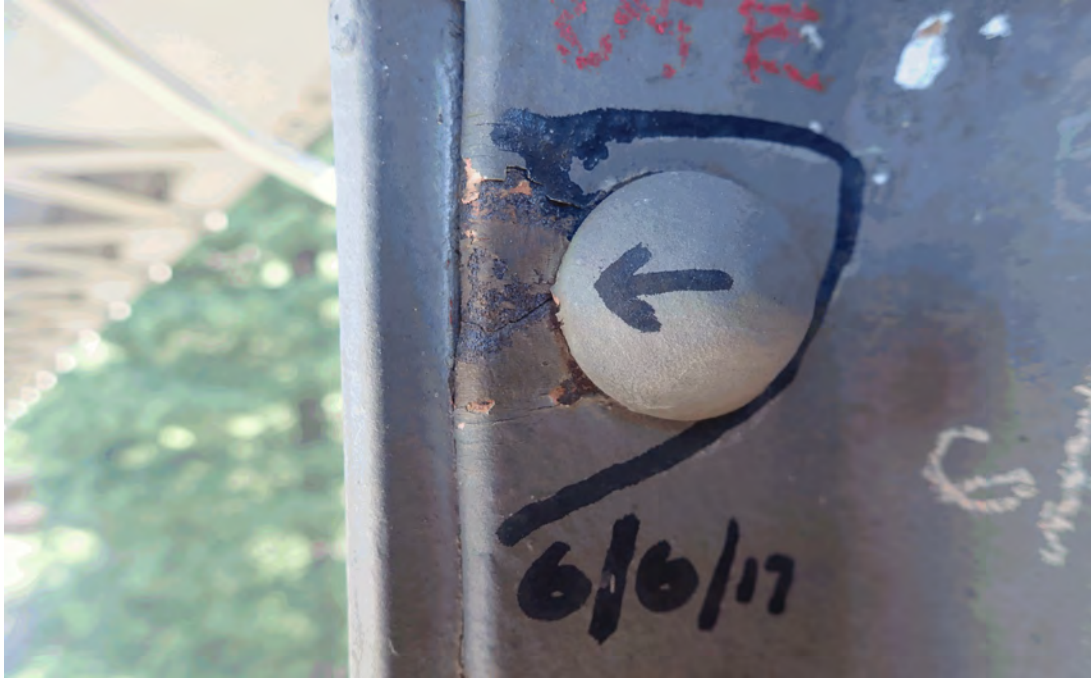
(CS 3) Crack in L5E-U5E at U5E.

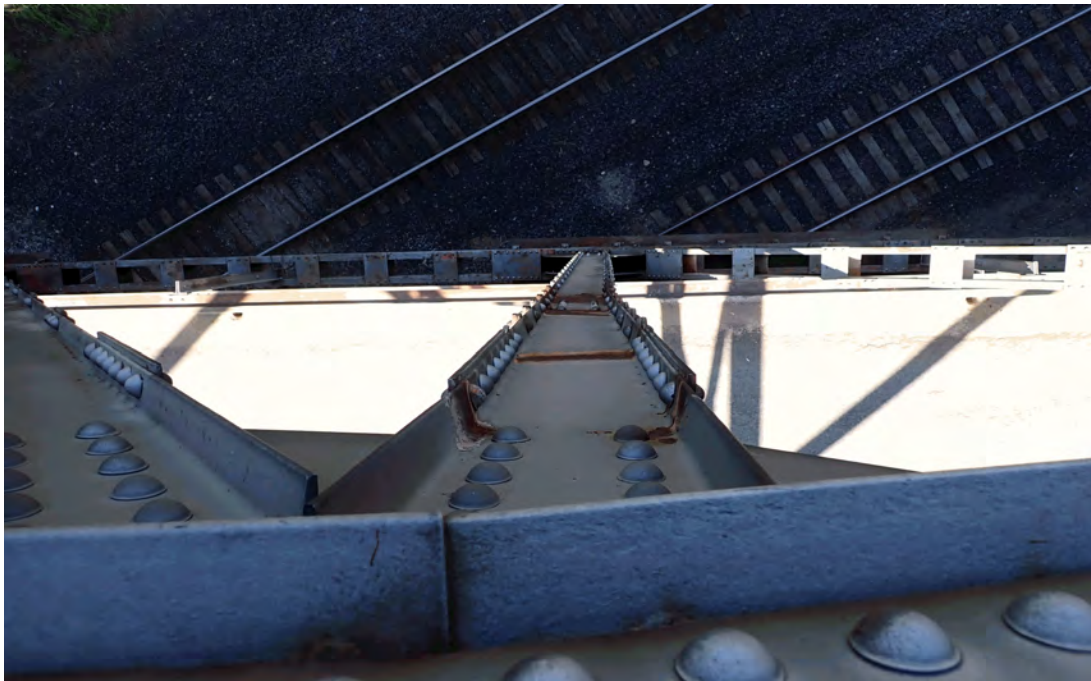
(CS 3) Distortion in L5W-U5W.

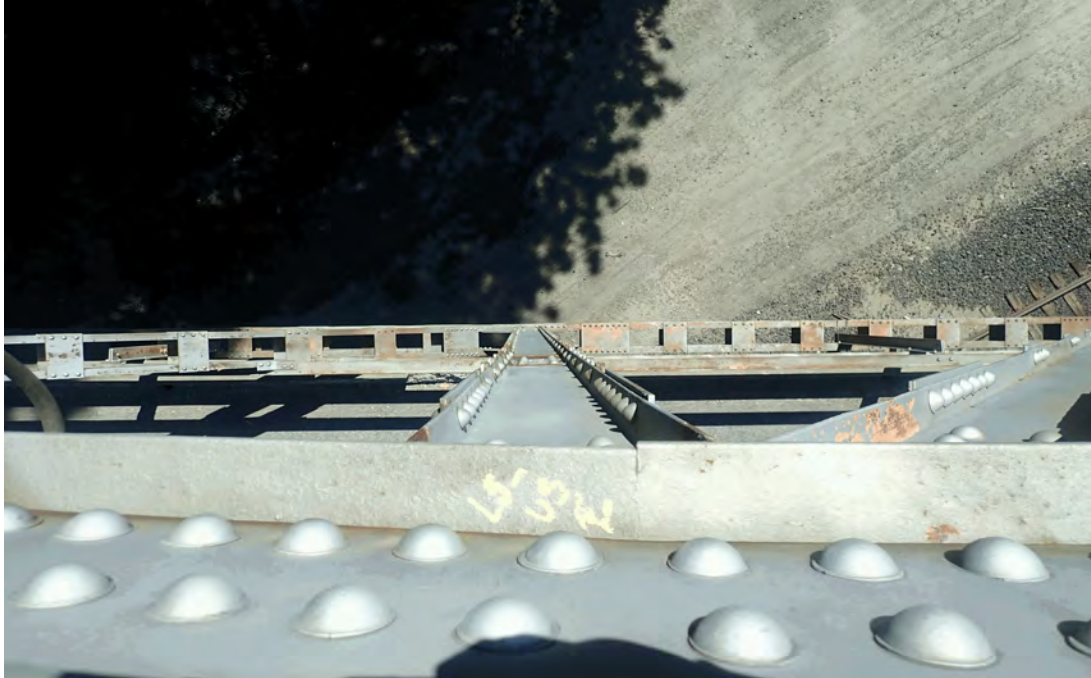
(CS 3) Distortion in L5E-U5E.

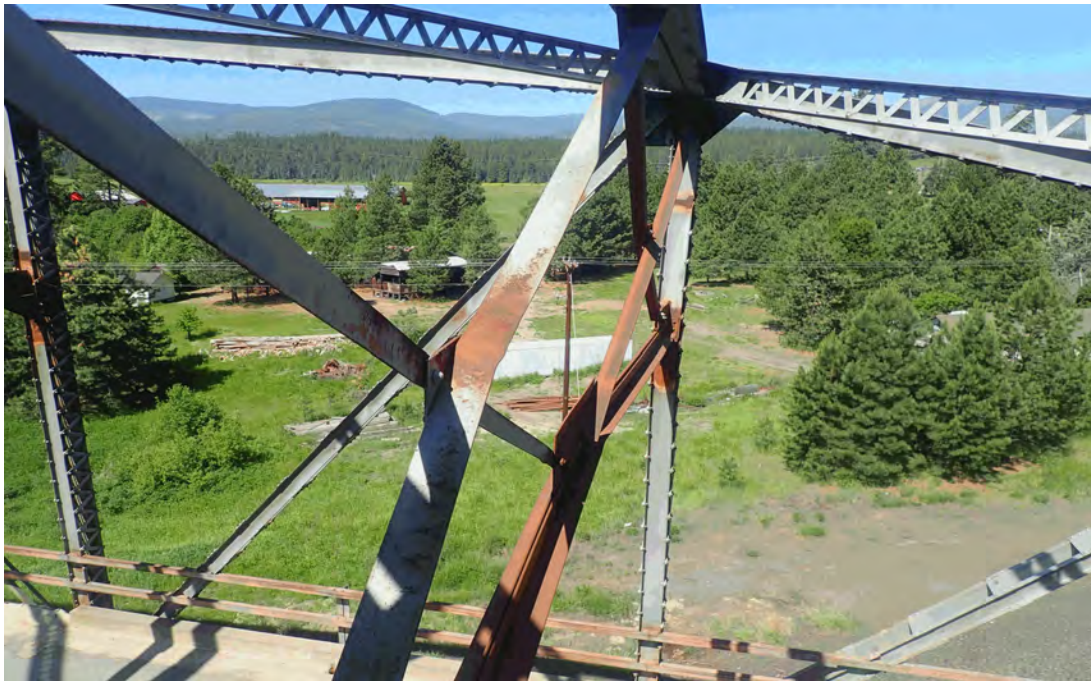
(CS 3) Impact damage to U5W-U5E sway brace looking west.

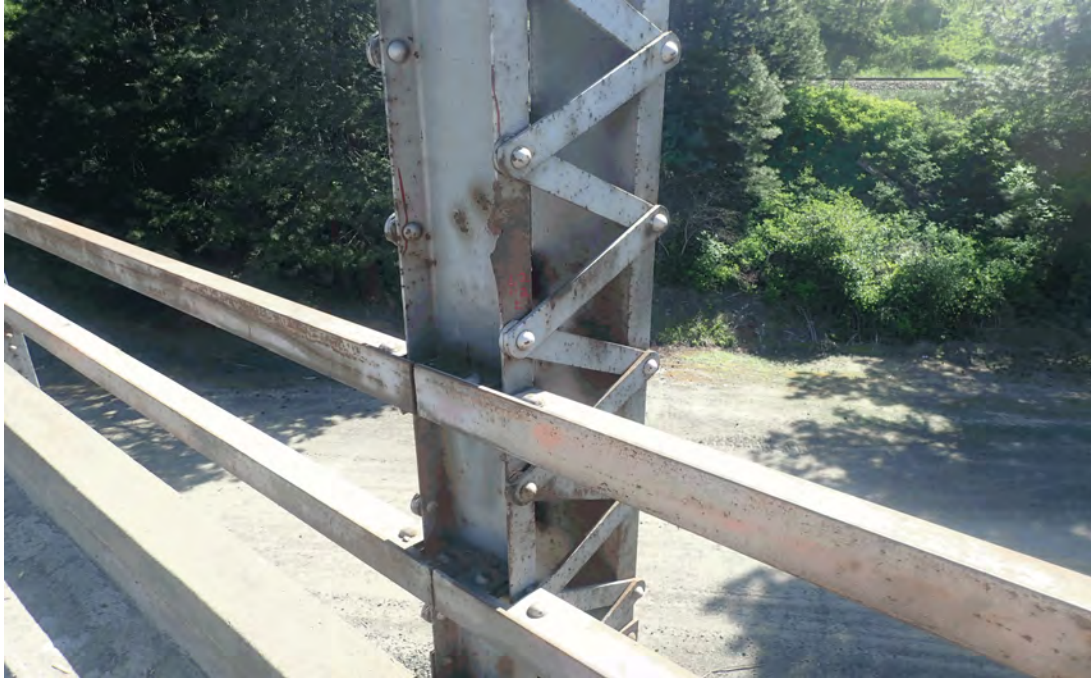
Vertical L2E-U2E has impact damage on the southwest flange and is bent 1.5 inches out of plane over a 5 inch length with a 2 inch tear. Minor out of plane bending in L4E-U4E. (CS 3) L6E-U6E has a 6 inch high x 2 inch wide area of out of plane bending located 3 feet above the deck. Impact damage to the L5-U5 sway brace has caused the verticals to slightly buckle inward on both trusses. Vertical L5-U5 on both trusses are out of plumb by 1.5 inches. All four sway braces have impact damage and were bent out of plane to the north and south by 3 to 6 inches. The rear south portal member has up to 2 inches of out of plane bending near the east end due to impact from an over height logging truck. A 1 inch deep dent can be found at the area of impact.

Impact damage to L2E-U2E looking north.

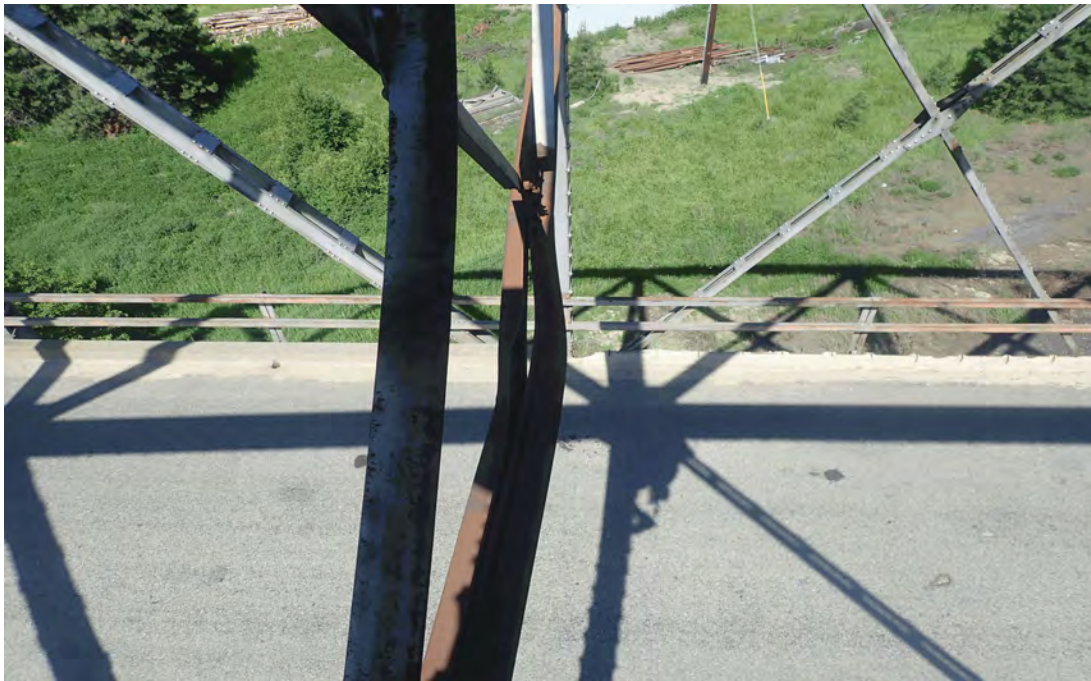
(CS 3) Typical impact damage to sway bracing.

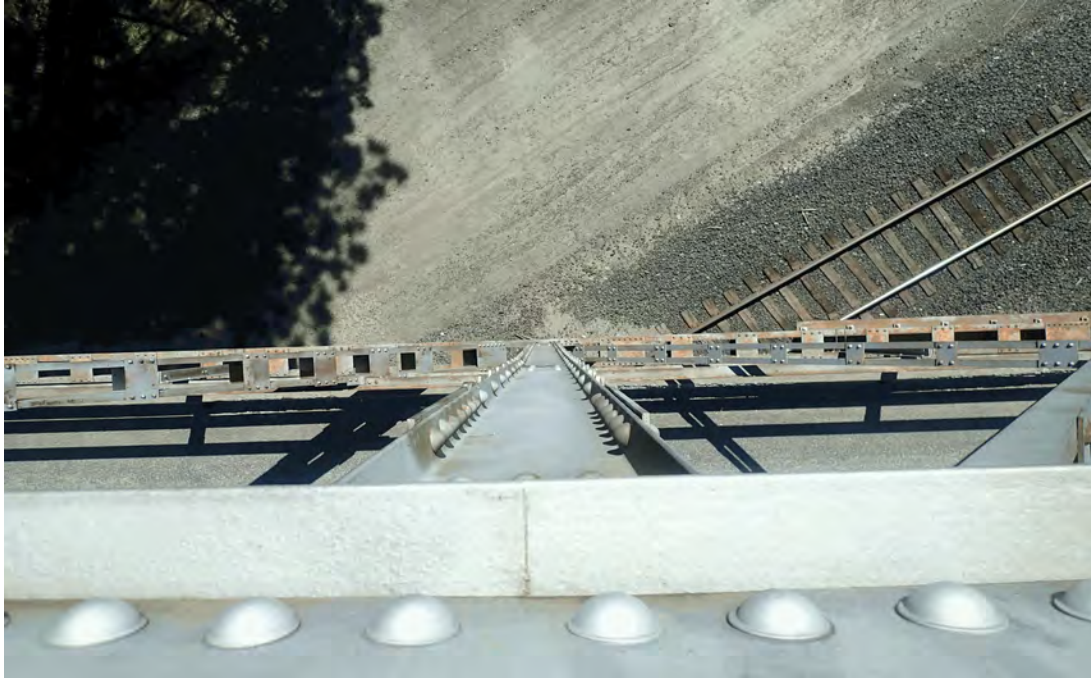
Out of plane bending in L4E-U4E.

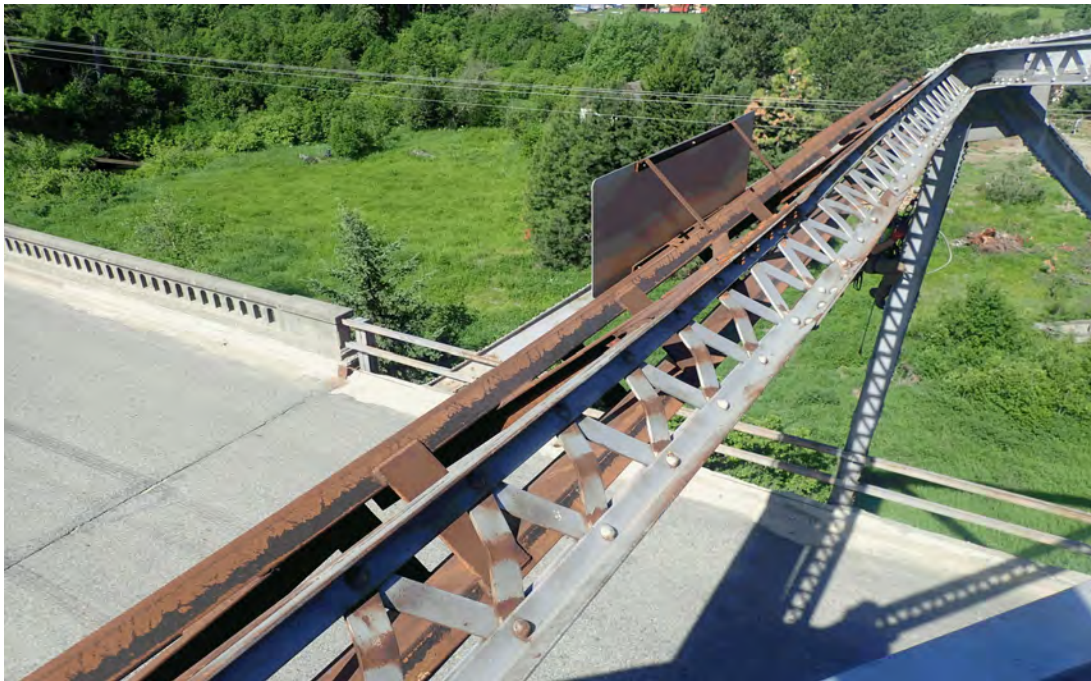
Impact damage and distortion to the south portal looking southwest.

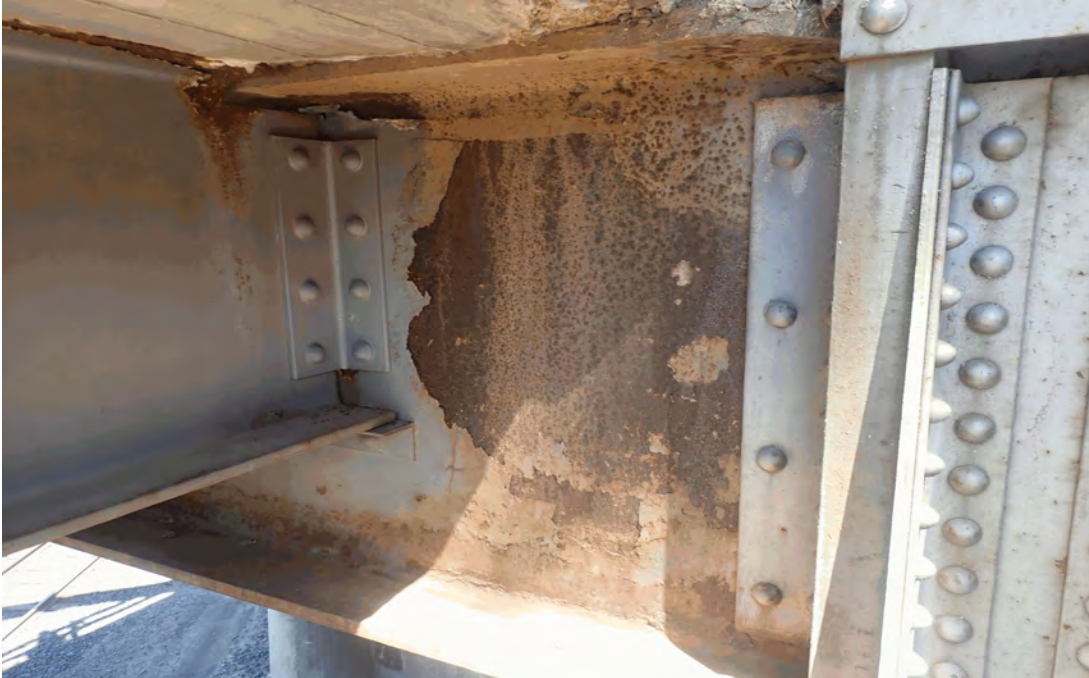
Typical corrosion at the floorbeam ends.

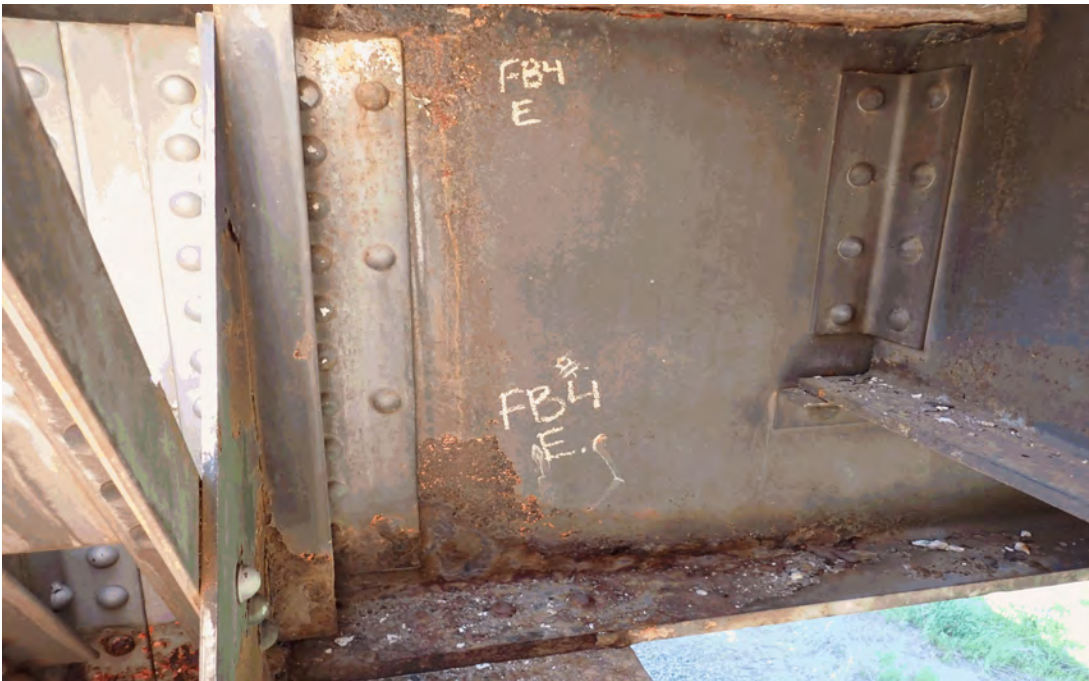
The floor beams have surface corrosion at areas of coating failure with more significant corrosion on the outer 2.5 feet of each floor beam due to debris buildup. (CS 3) The lower webs have areas of 1/16 inch thick delamination and pitting. Floor beam 6 has a 4 inch area of 1/16 inch deep pitting in the center of the north face at the top of the web Floor beam 6 has moderate corrosion in the lower 3 inches of the web and the top of the bottom flange with pitting up to 1/8 inch deep for 3 feet. There are delaminations at the floor beam ends that are up to 20 inches high and up to 30 inches long at the east end of floor beams 0, 1, 2, and 3 and at the west end of floor beams 3, 4, and 5. On the north face of floor beam 3 at L3E there is an area of 0.29 inch thick delamination near the bottom of the web. On the north face of floor beam 3 at L3W there is an area of 0.27 inch thick delamination near the bottom of the web. On the north face of floor beam 3 at L4W there is an area of 0.28 inch thick delamination near the bottom of the web.

(CS 3) Typical areas of corrosion with loss of section on the floorbeams.

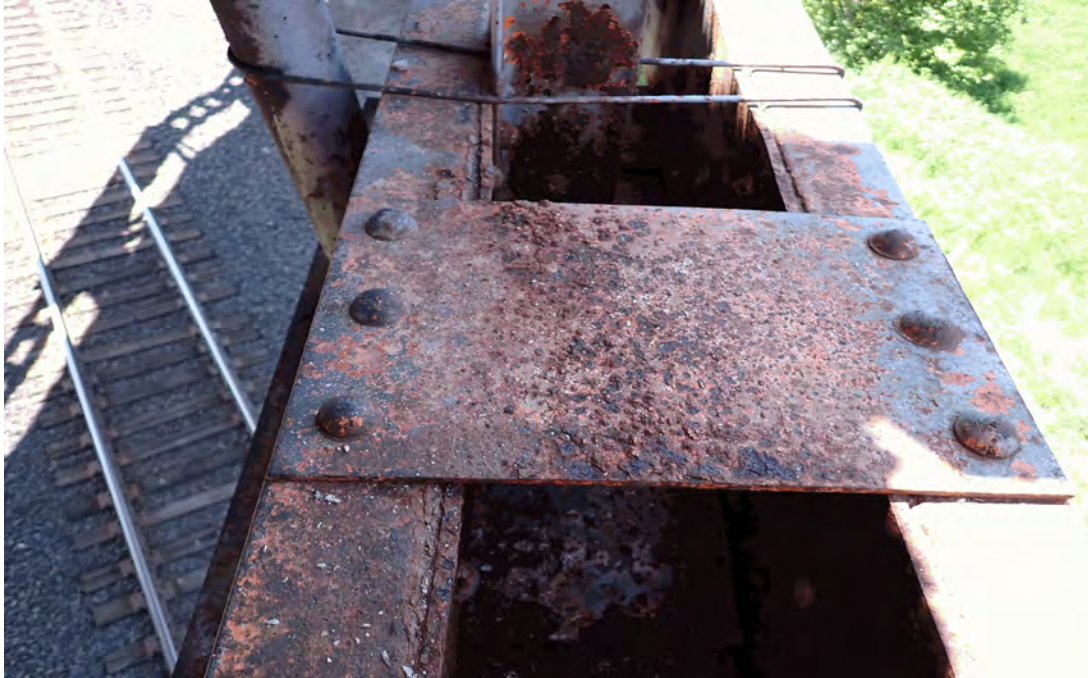
Surface corrosion at locations between the web plates and bottom chord channels. There is no coating on the portals and sway braces with minor corrosion throughout. (CS 3) Bottom Chords L1E-L4E and L3W-L6W have 1/16 inch thick pack rust which is causing out of plane bending between the bottom chord and the stiffener plates. 1/4 inch diameter pitting nodules up to 1/16 inch deep on the bottom chord members.

(CS 3) Typical pitting in L3E-L4E looking south.

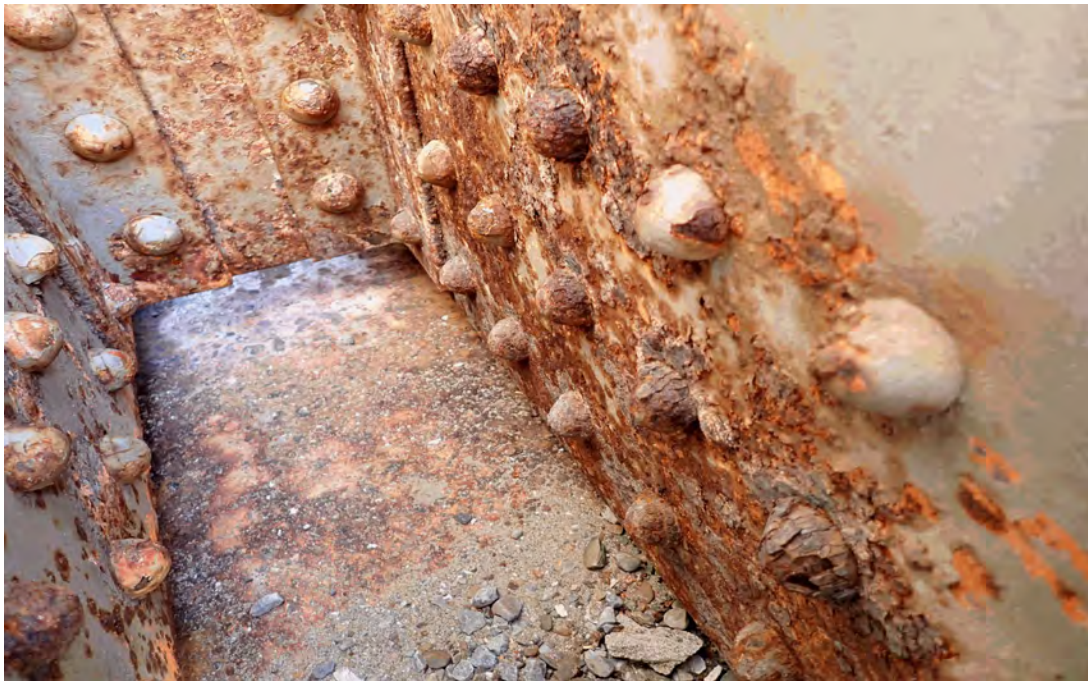
Typical corrosion of the rivet heads on the bottom chords.

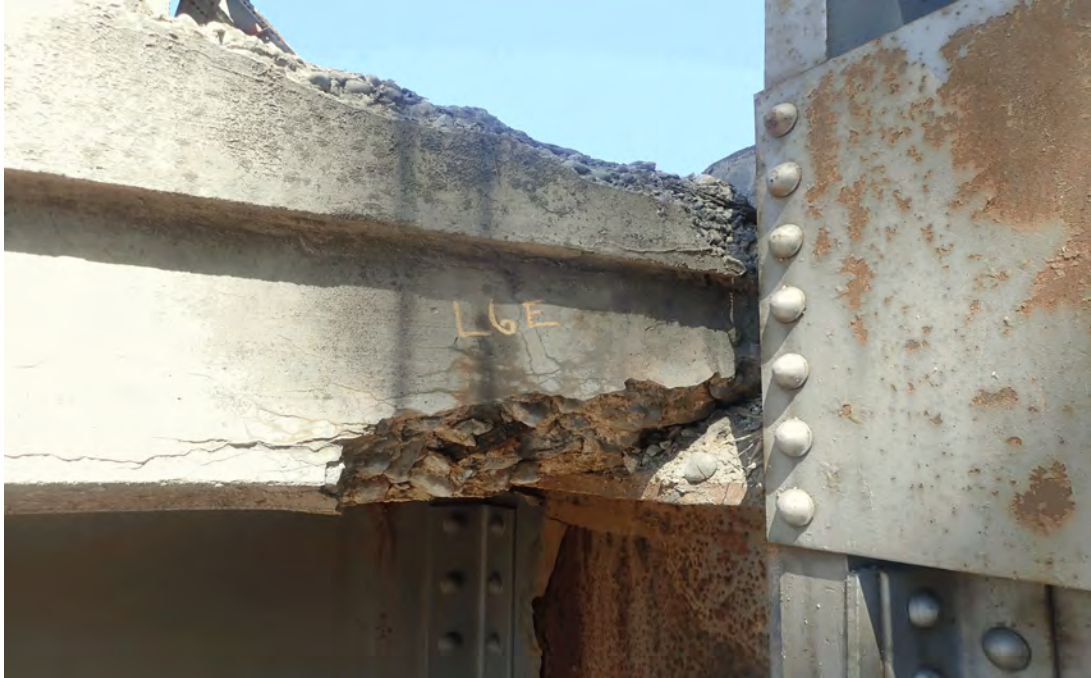
Spall in the east edge of the deck on the south side of floorbeam 6 looking northwest.

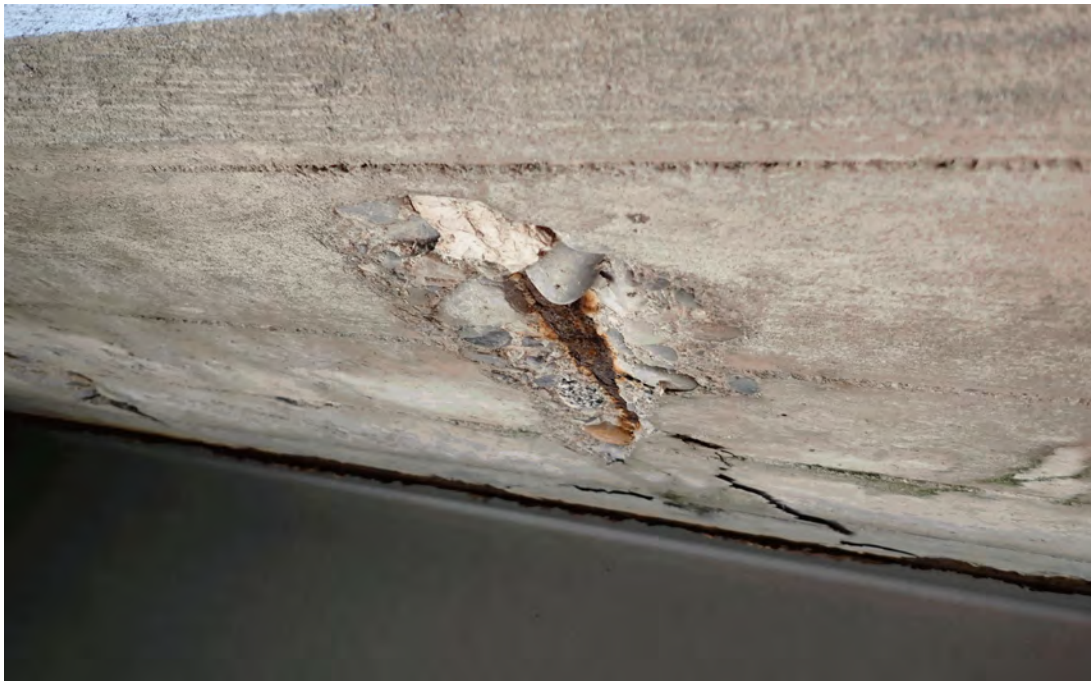
(CS 3) Typical spall in the underside of the deck.

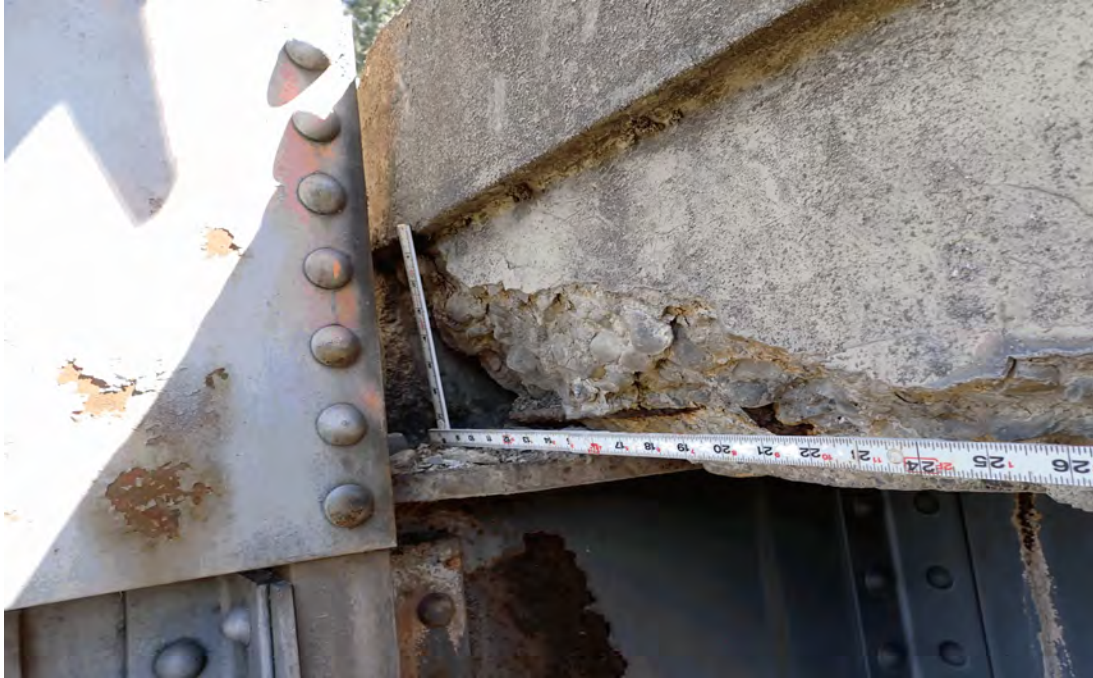
(CS 3) Spall in the west edge of the deck at floorbeam 6 looking north.

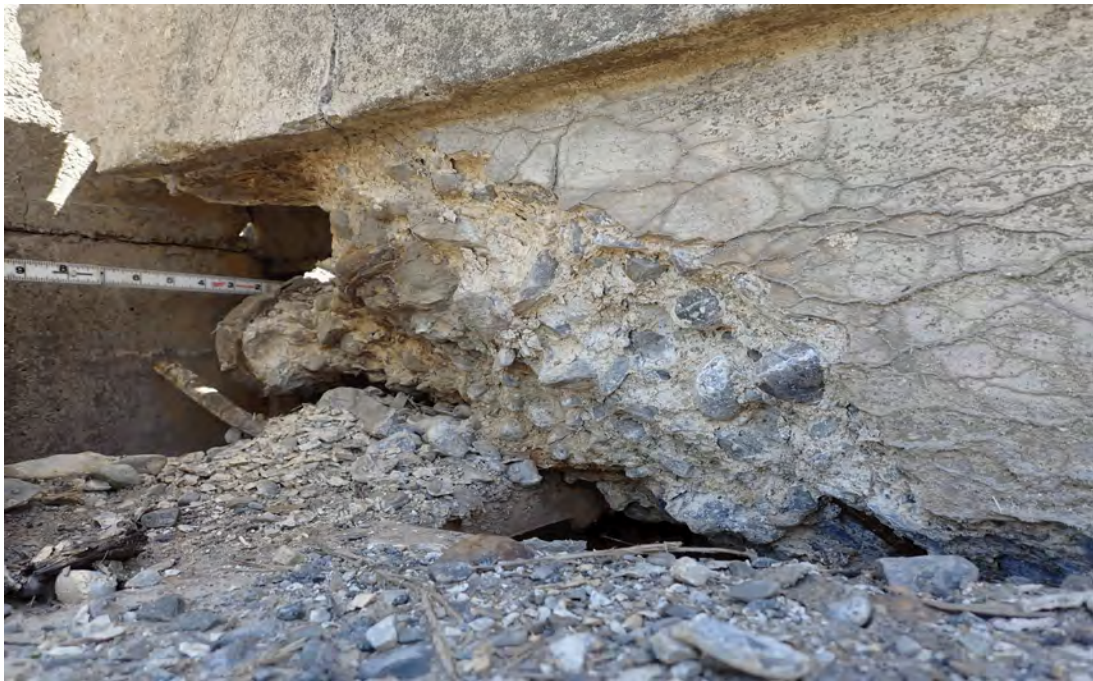
(CS 3) Spall in the northwest corner at floorbeam 7 looking northeast.

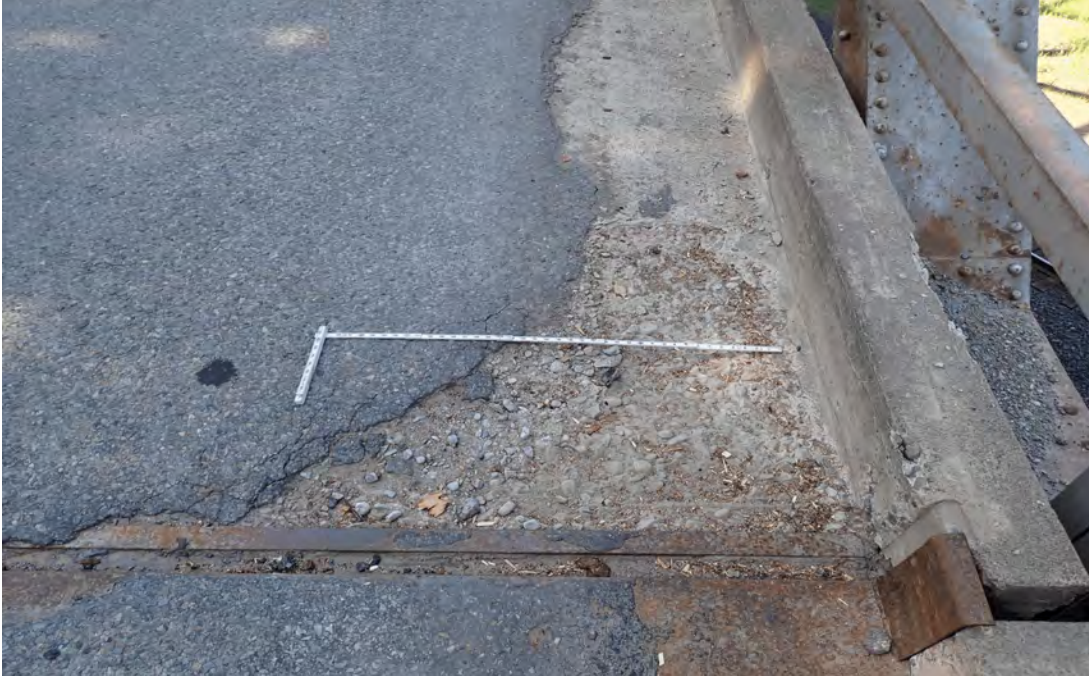
(CS 3) Spalling in the top of the deck at the north end of span 7 looking south.

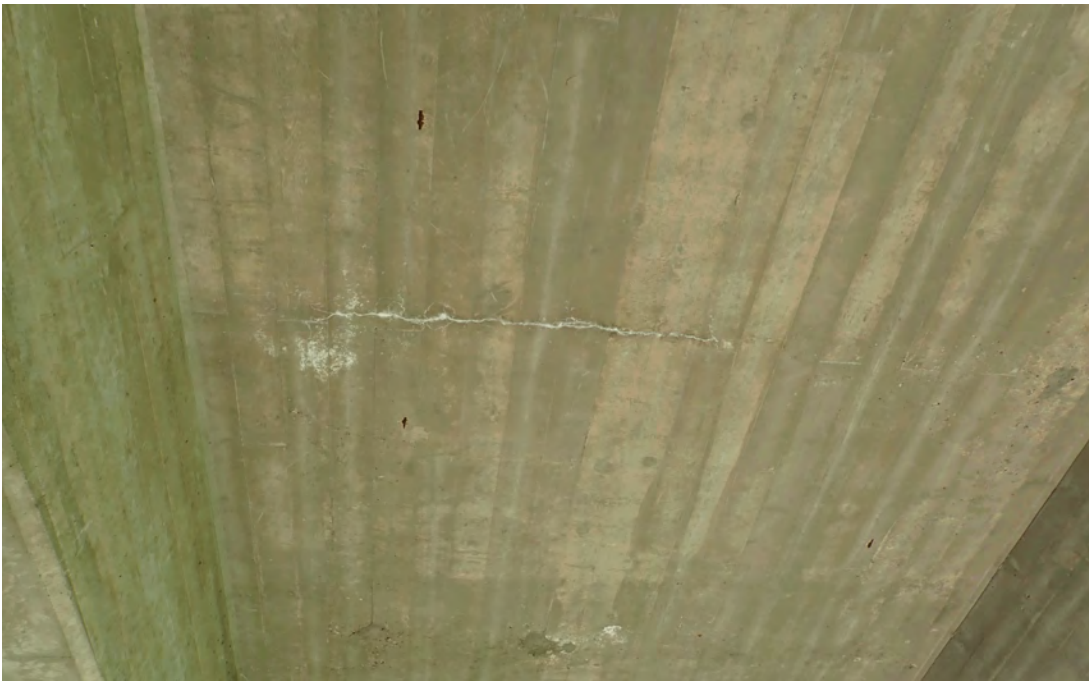
Typical cracking with efflorescence in the underside of the deck.

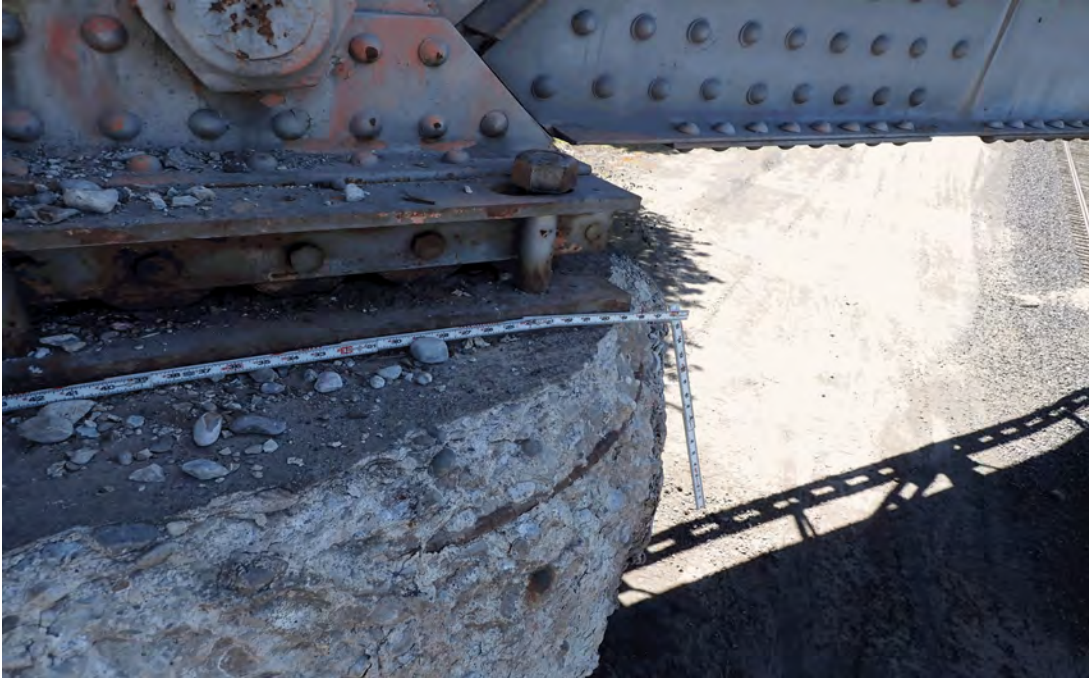
Pier 7 has a 3 foot long x 2 foot high spall with associated cracking, efflorescence, and an exposed and corroding rebar at the top of the west corner.

(CS 3) Spalling and deterioration of the cap at pier 7.

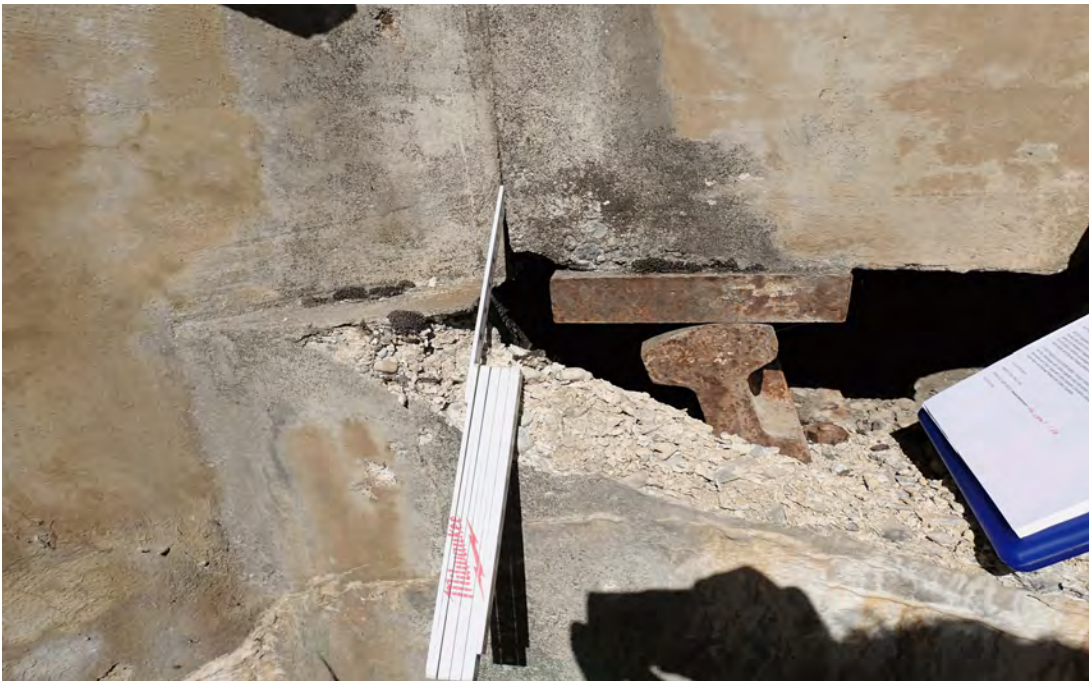
(CS 3) The south abutment has a 2 foot long x 6 inch wide x 4 inch deep area of disintegration at the east girder pedestal. The north abutment has a 2 foot long x 1.5 foot wide x 4 inch deep spall with exposed rebar west girder pedestal.

(CS 3) Spalling of the southeast bearing at the south abutment looking west.

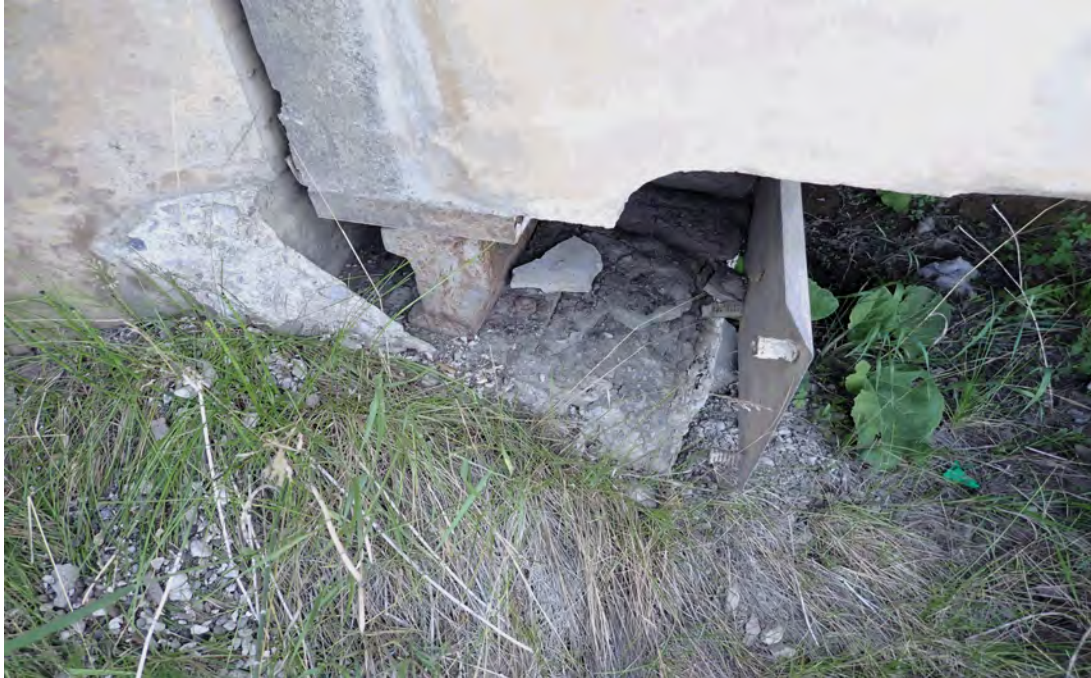
(CS 3) Spalling at the northwest bearing at the north abutment looking east.

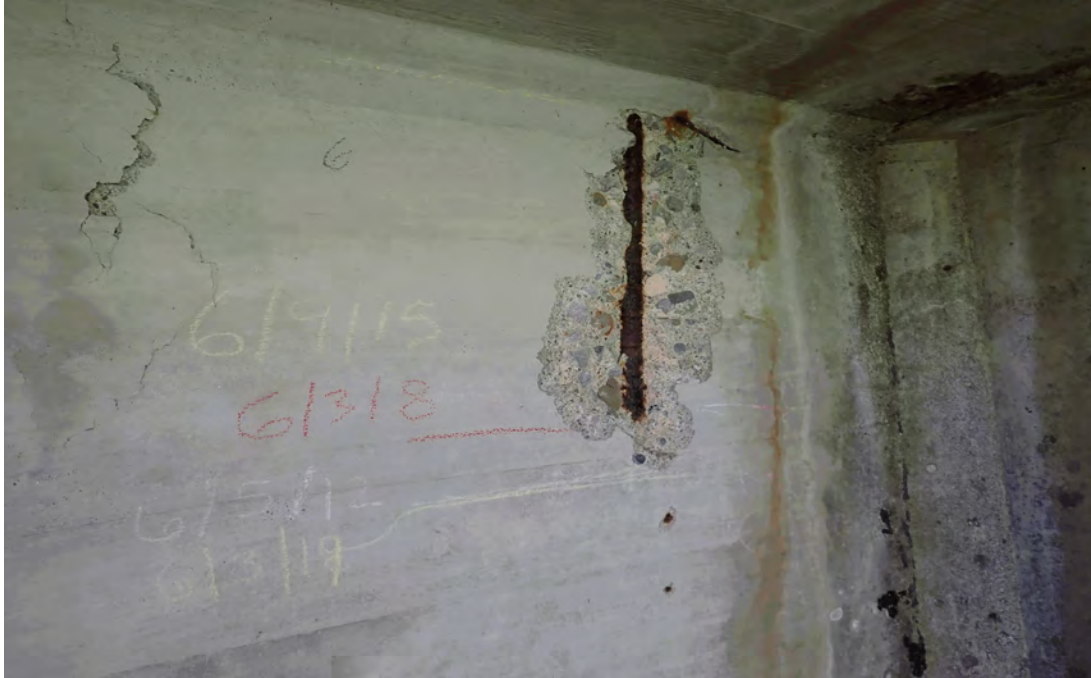
Spall in the west exterior girder at the south abutment looking east.

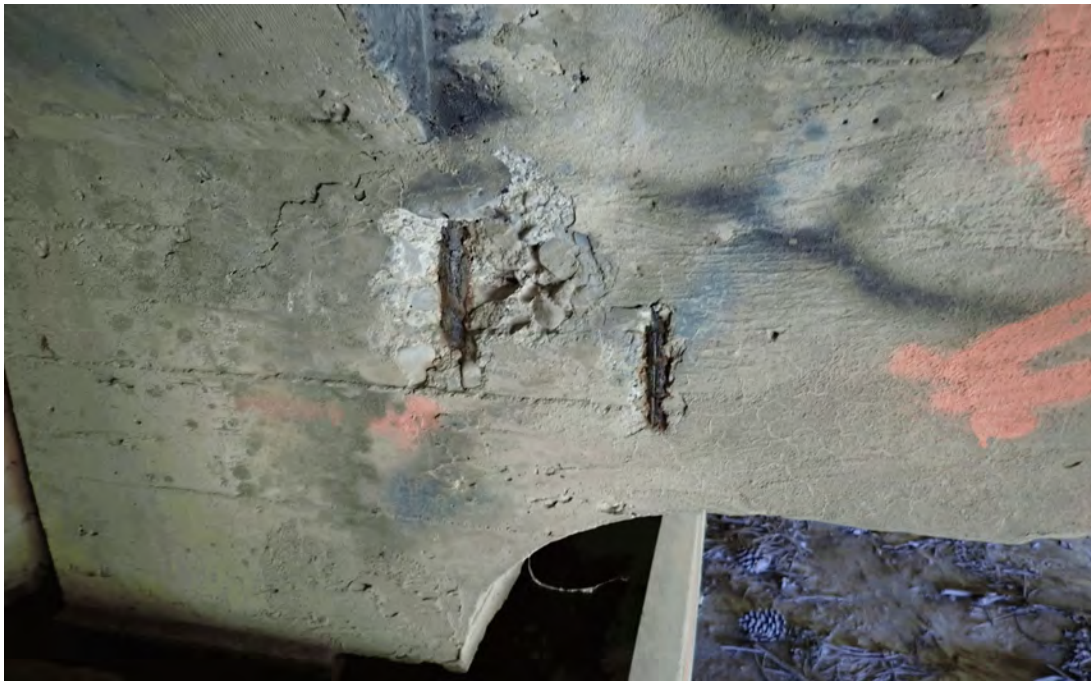
(CS 3) Spalling with exposed and corroding rebar in the center girder at the north abutment looking east.

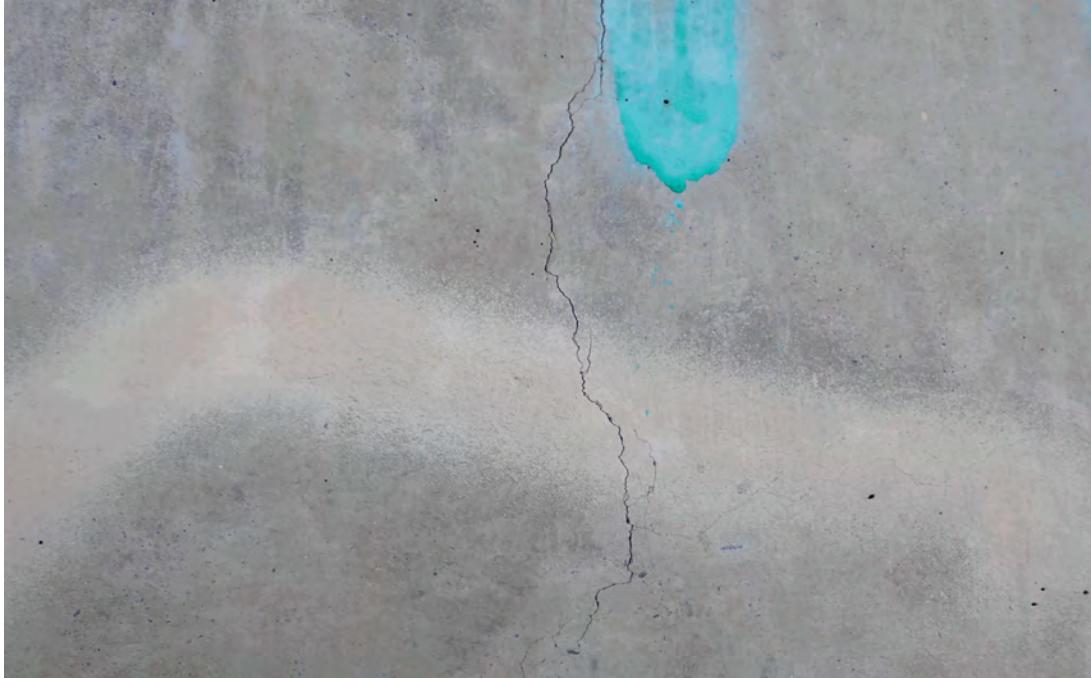
1130/3	Cracking (RC and Other)	30	ft	0	30	0	0
	<i>The girders have hairline to 1/32 inch wide vertical cracks.</i>

Typical cracking in the approach span girders.

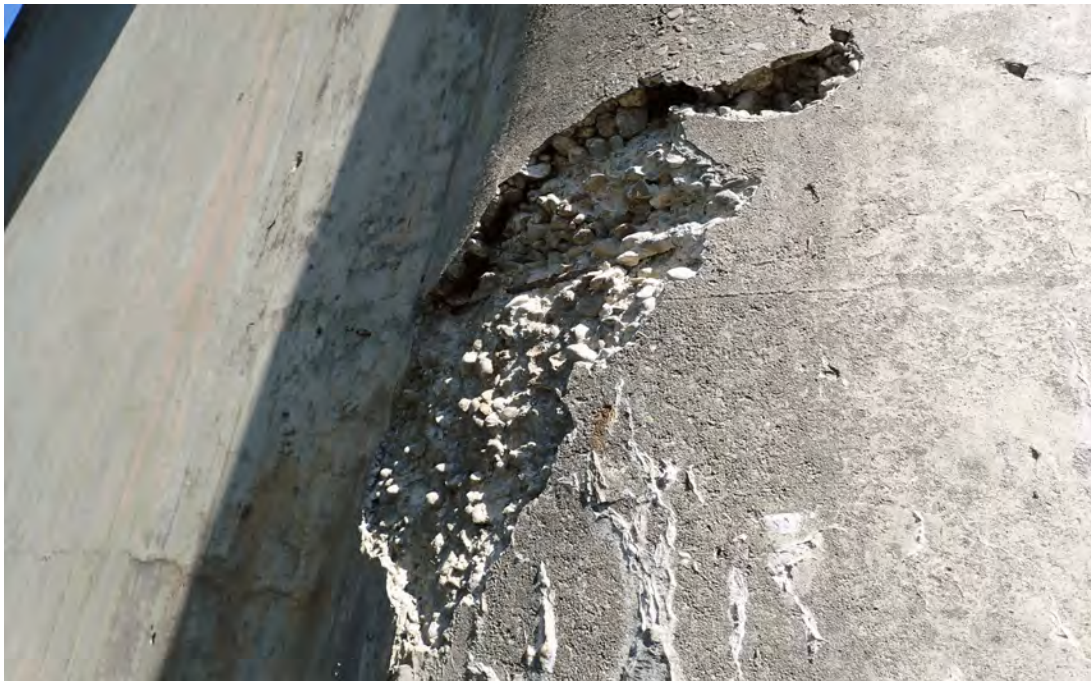
(CS 3) Pier 4 east column 3 has a 1 square foot spall on the north side. Pier 6, Column 2 has a spall with exposed and corroded rebar that is 3 square feet x 3 inches deep with associated efflorescence staining and cracking.

(CS 3) Spall in the south face of column 2 at pier 6 looking northwest.

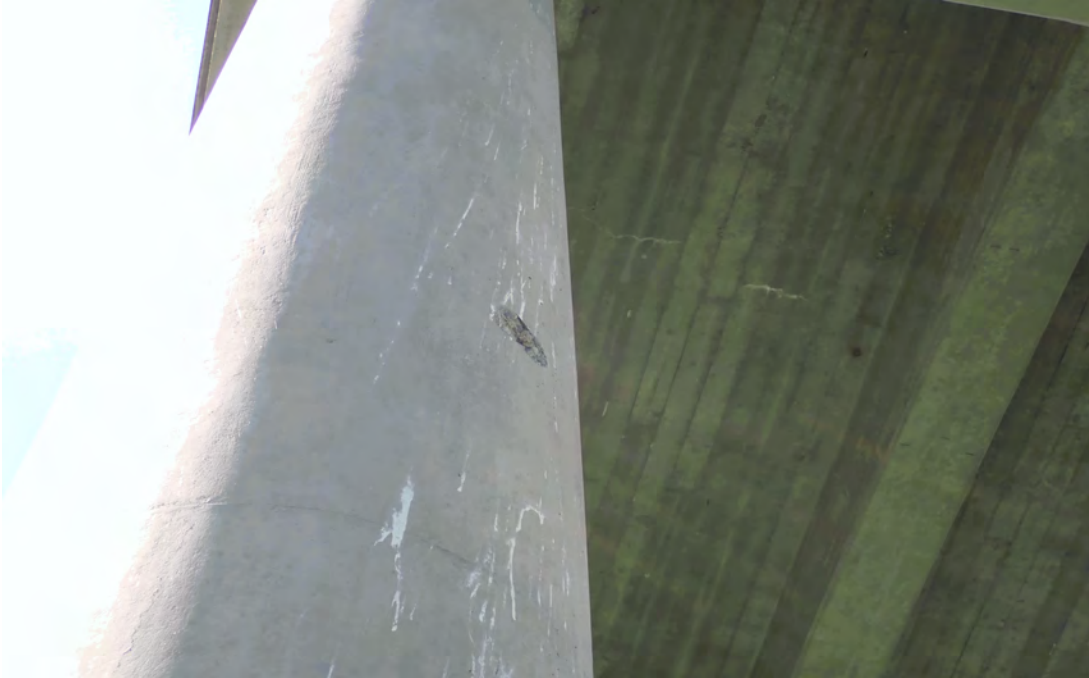
(CS 3) Spall in column 3 at pier 4 looking south.
