Idaho Transportation Department Bridge Inspection Report

Bridge Key:	30315	Structure Name:	95907A 0.24
(6)Features Intersected:	BNRR;UPRR & DEEP CREEK	(9)Location:	0.1 S. NAPLES
Facility Carried(Route):	S5907;DEEP CRK LP	Admin Jurisdiction:	2100 Boundary County
Xref Structure Name:		District:	01

Inspector Number and Name: 1021 - Dylan Moss, Collins Engineers

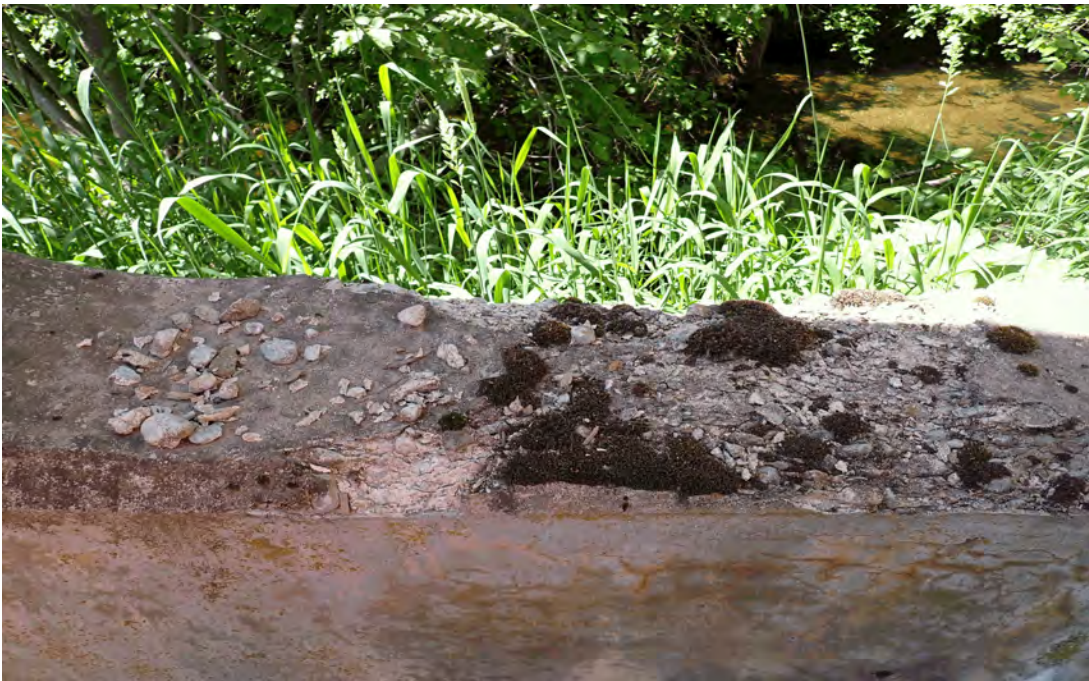
(CS 3) The top of the west lower wall of Pier 3 has a 4 foot long x 1 foot wide x 2 inch deep spall with two exposed rebar. The east lower wall of Pier 3 has a 4 foot long x 1 foot wide x 1.5 inch deep spall.

(CS 3) Typical spalling in the top of the lower pier 3 wall looking south.

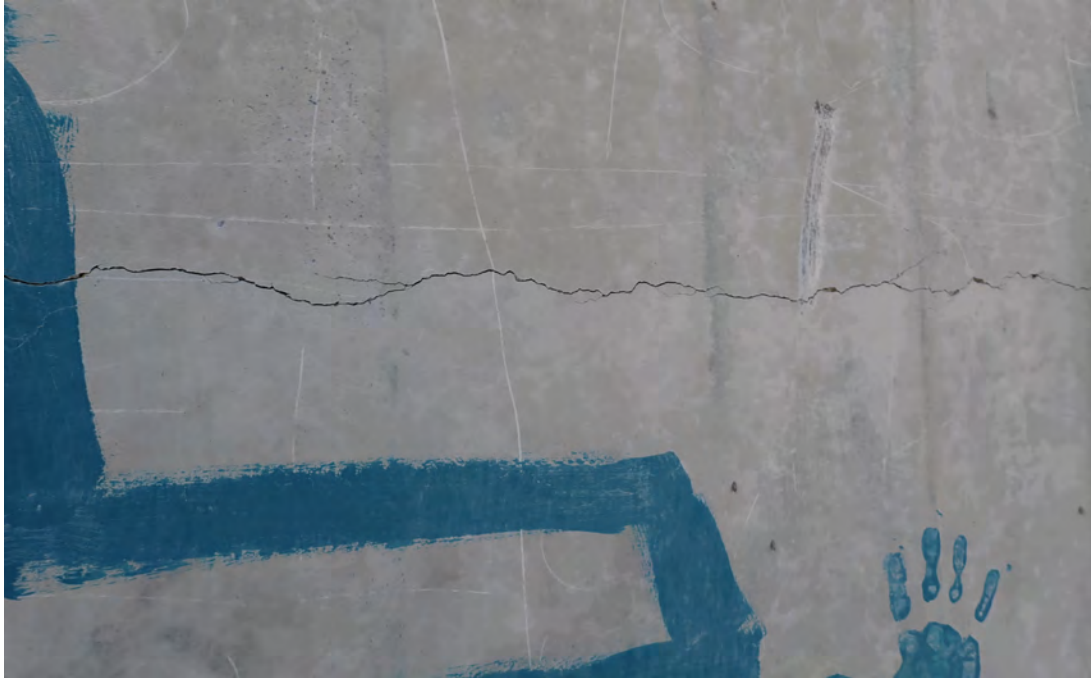
1/32 inch wide cracks in the west lower wall of pier 4, the lower wall of pier 5, and (CS3) 1/16 inch wide cracks in both sides of the pier 6 wall.

Typical cracking in the pier walls.

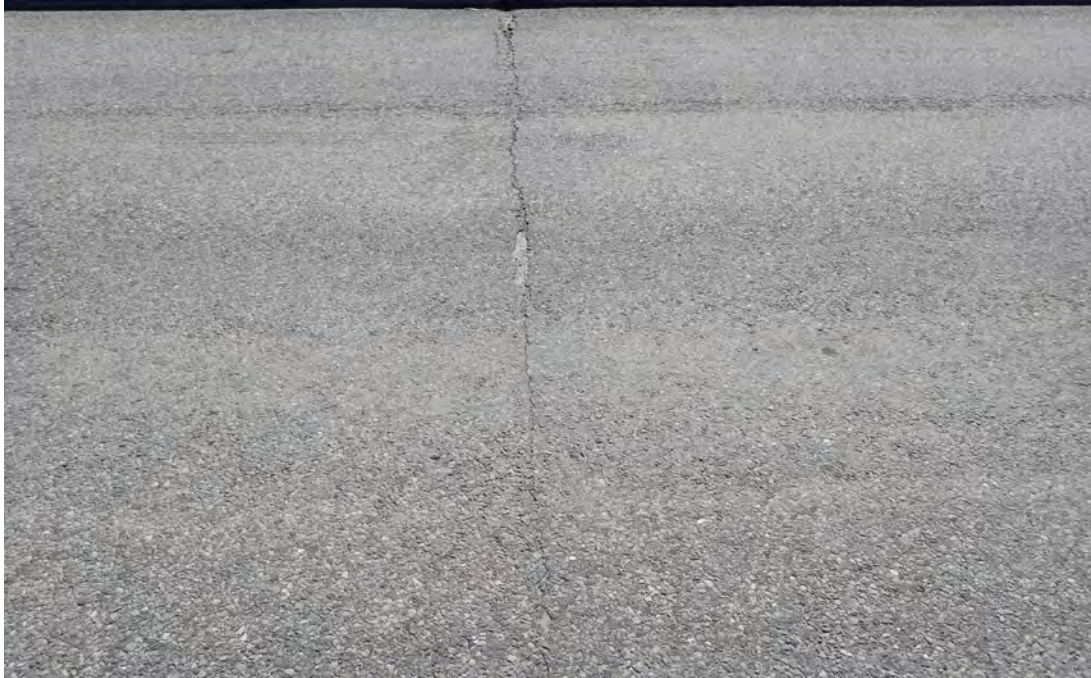
Sliding steel plate at Pier 3, Pier 6, Pier 7, and the north abutment. (CS 3) Joint at pier 6 is completely closed and the joint at pier 3 is impacted with dirt and debris. (CS 3) Joints have been cleaned, exposing areas of moderate corrosion on all the joints with evidence of leakage.

Joint over pier 3 looking east.

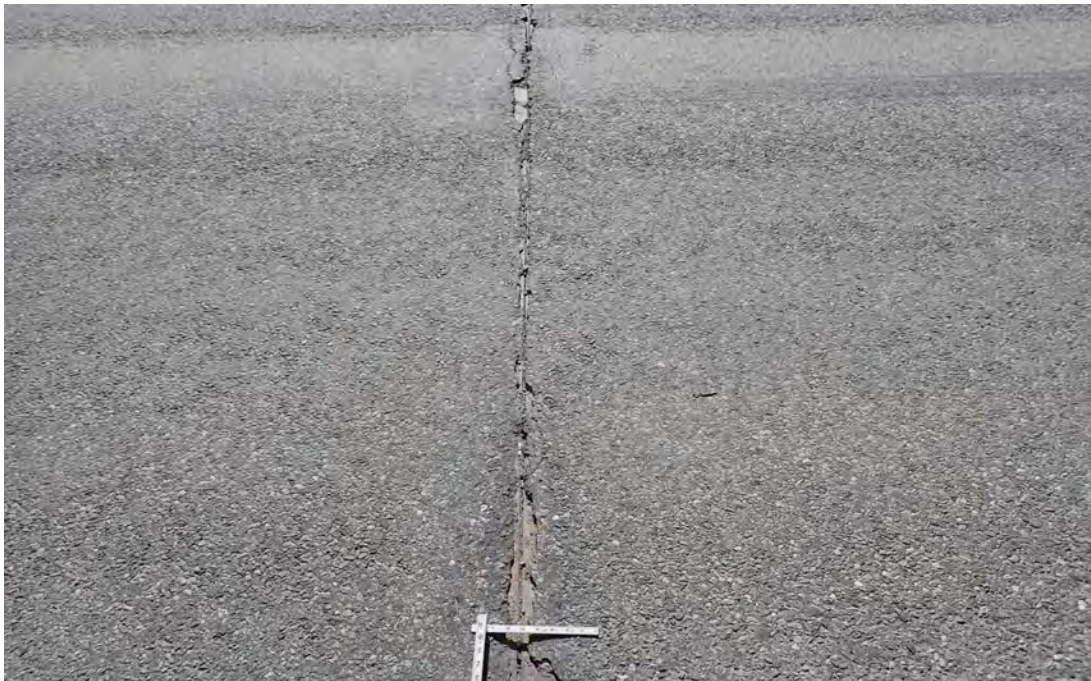
Joint over pier 6 looking east.

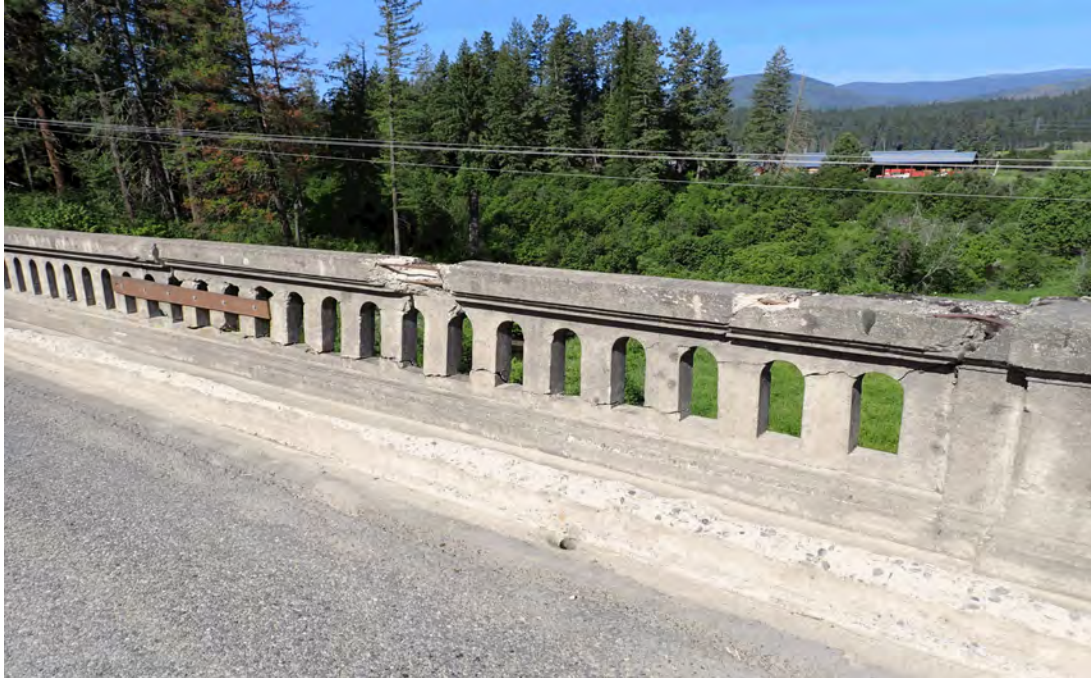
(CS 3/4) The integral curbs have spalling along the top corner exposing rebar with surface corrosion in over 50 percent of the approach spans. Between Piers 3 and 4 on the west rail there are severe impact damage spalls along the concrete rail and a 20 foot section has broken and is only being held up by a steel repair and the reinforcing rebar.

(CS 3/4) Broken bridge rail on the west side of span 4 looking southwest.

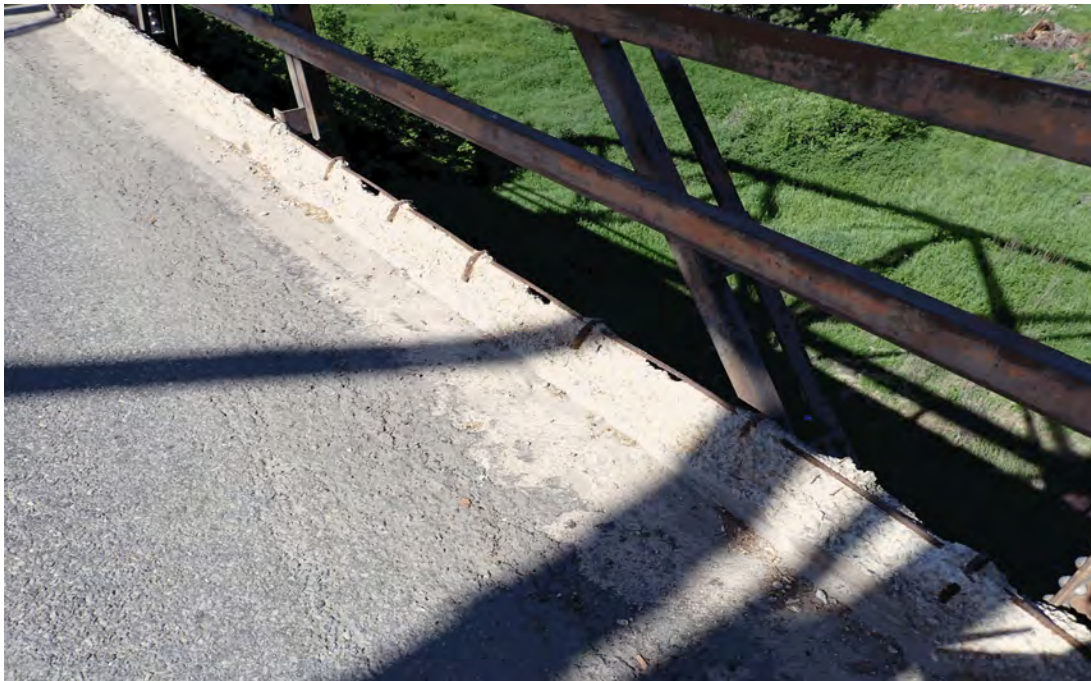
Typical spalling of the curb in the truss span.

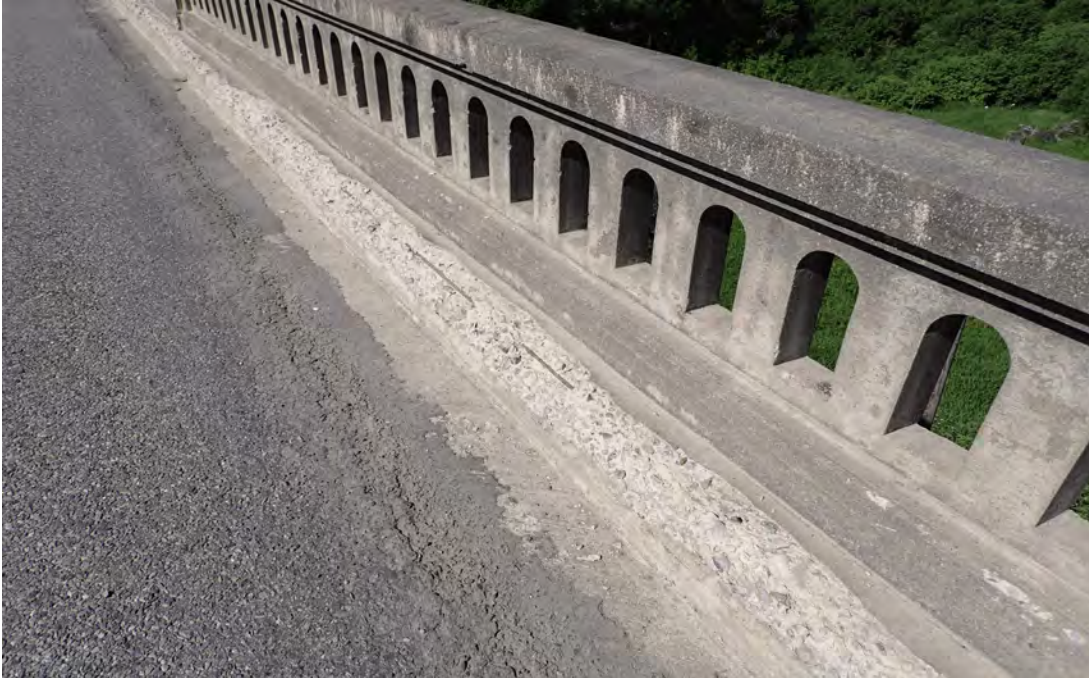
Typical spalling of the curbs in the approach spans.

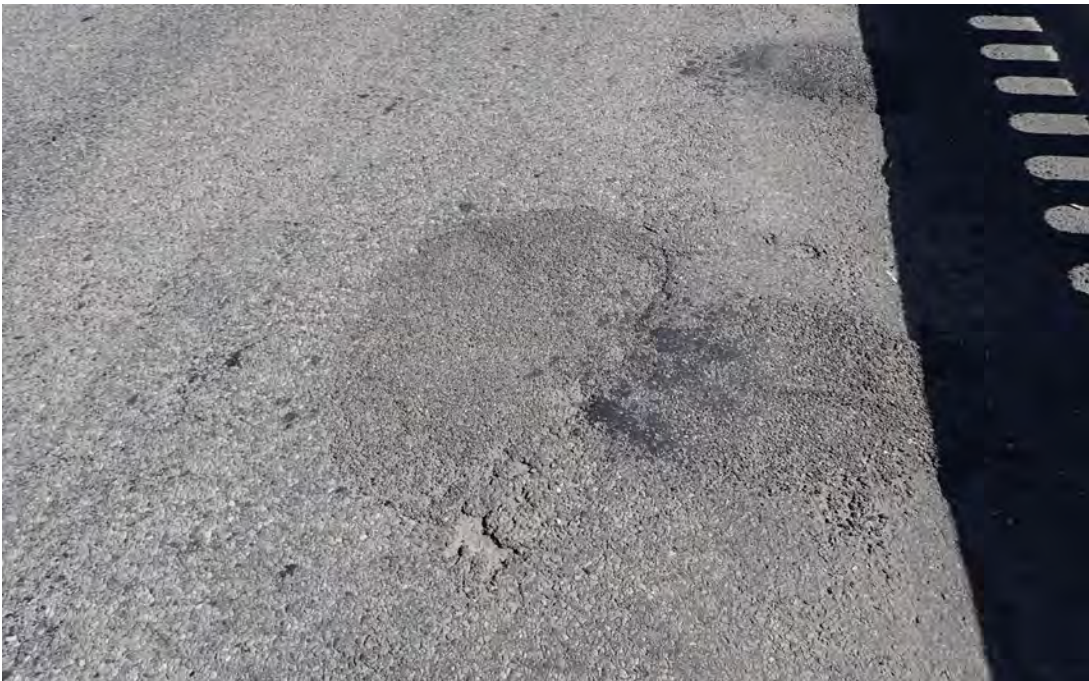
Typical patch in the wearing surface.
