# ITD BRIDGE ASSET MANAGEMENT (BAM!!!)

# Idaho Summary of the National Bridge Inspection Program (23 Metrics)

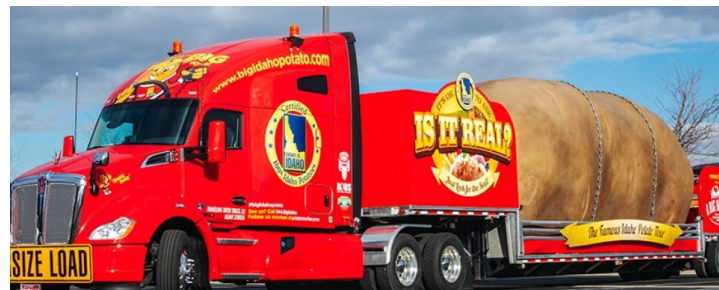
A bridge load rating is the amount of live load (vehicle load) a bridge can safely carry. A bridge has an overall capacity (strength) but uses up some of that capacity supporting its own dead-load (self weight).

Live Loads are moving loads.

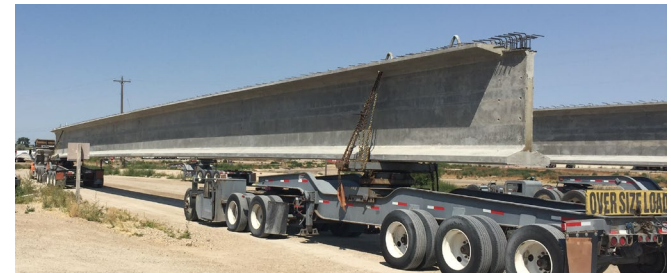
# Idaho Legal Trucks

IDAHO MANUAL FOR BRIDGE EVALUATION-----SECTION 6: LOAD RATING  
APPENDIX 6.2.1 IDAHO LEGAL TRUCKS SCHEMATICS

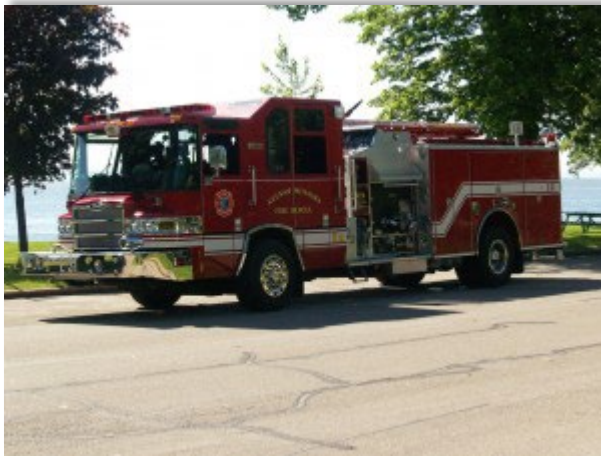
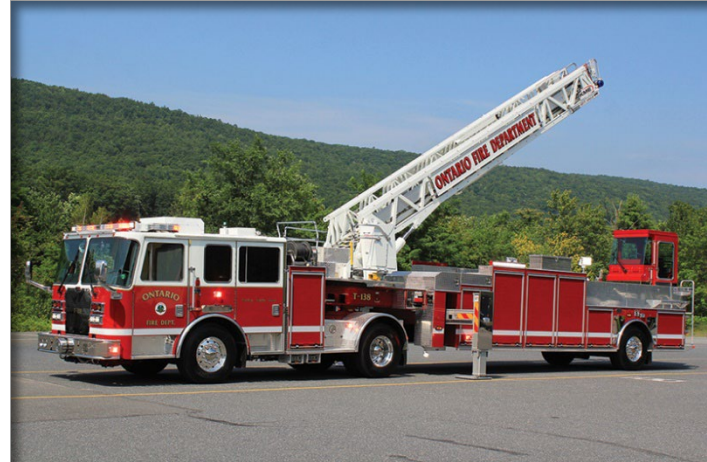
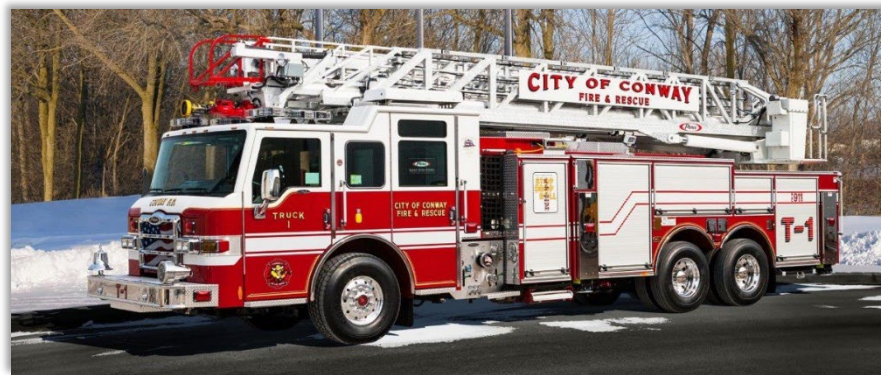
# EV's

## Emergency Vehicles
